Mobile Wastewater Treatment Helps Remediate Concentrated Acidic Process Water at Fertilizer Plant

Bill Perpich Jr., Chris Soule, Sam Zamani, Louis Timchak, Gary Uebelhoer, Lnsop Nagghappan, and Robert Helwick

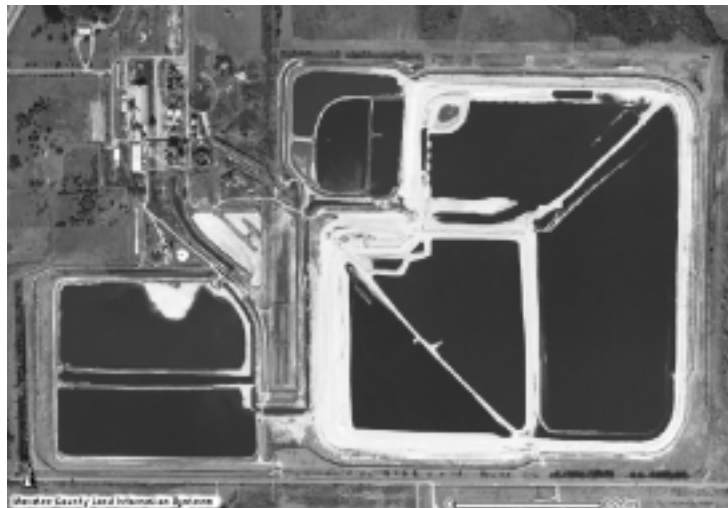
Four ponds are located on top of the Piney Point gypsum stacks with a series of smaller ponds located on the west side.

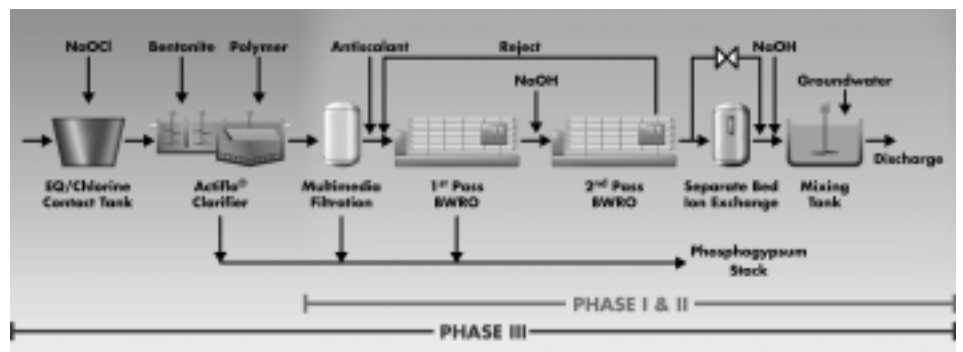
Figure 1 “LowpHRO” Process from Veolia Water Systems for Phosphogypsum Pond Water Treatment

Within five weeks of the contract award, startup commenced and Phase I was underway. Phase I equipment included filtration, followed by two-pass RO. Filtration consisted of dual media roughing filters, followed by multimedia polishing filters. All phases of the project and associated treatment scheme are shown in Figure 1.

The system was designed to operate at the low pH conditions in the feed water, making no adjustments. The RO system was designed for a double-pass configuration, with the first pass being operated at a very low pH (< 3.0), and the second pass being operated at a close-to-neutral pH.

scaling due to silica, fluoride, sulfates, and phosphates present in the feed water at saturated concentrations and to improve the rejection of ammonia present in the feed water. The low pH operation of the first pass RO helped in the promotion of hydrofluorosilicic acid, bisulfate, and phosphoric acid equilibrium and prevented any potential scale formation.

The primary reason for operating the second pass RO at a close-to-neutral pH is to improve the rejection of fluorides, silica, phosphate, organics, and other weakly ionized compounds present in the feed water.

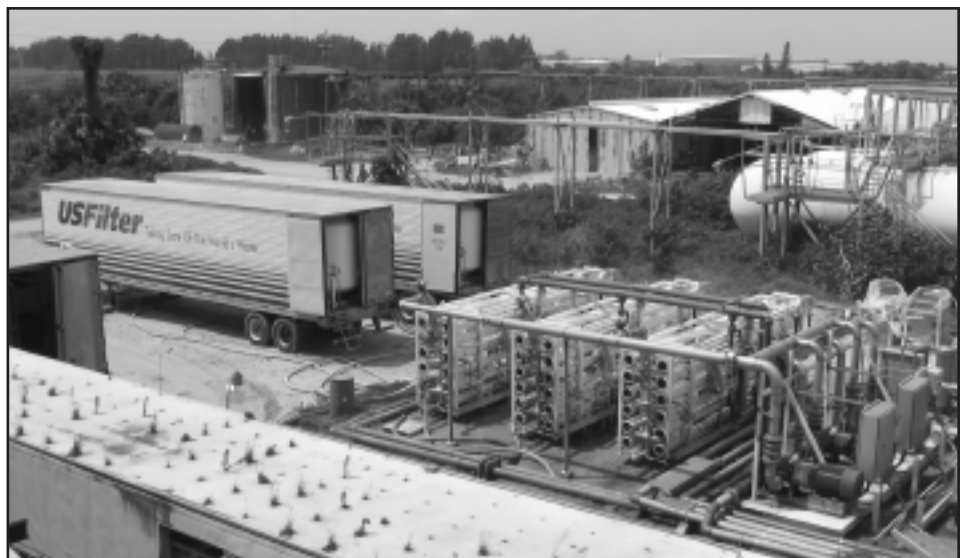
About half the Piney Point treatment system that includes media filtration, 2-pass RO, and off-site ion exchange regeneration.
